Firmware update procedure

Recording module: AU-VREC1,
Camera module: AU-V23HS1, AU-V35C1

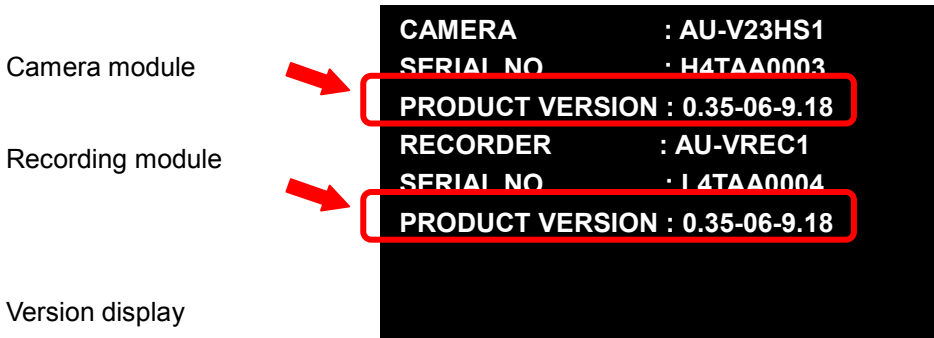
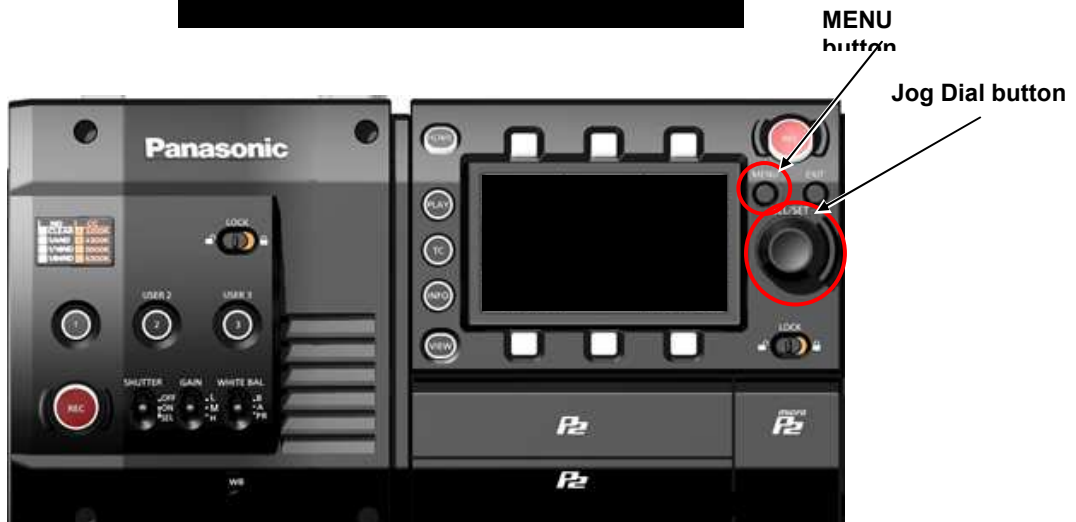
Version display example

1. Connect Camera module to Recording module. Switch ON the power of the camera recorder.
2. Press **MENU** button. Select "> SYSTEM SETTINGS >INFORMATION >VERSION" to display the current version with the **Jog Dial** button.

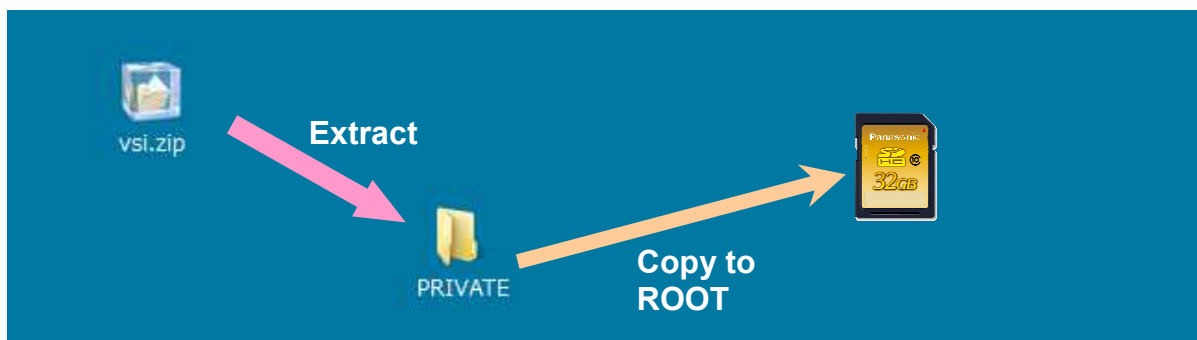
1. Insert an SD memory card into the SD card slot (NOT microP2 card slot) on the unit.
2. Format the SD card (MENU : SYSTEM SETTINGS > CARDS/MEDIA > FORMAT CARD > SD CARD)
Visit Panasonic professional video support website <http://panasonic.biz/sav/pass_e> and download "vsi*****.zip" firmware package.
3. Extract the ZIP package (you will see "PRIVATE" folder).
4. Mount the formatted SD card to the computer then copy the **"PRIVATE"** folder to the SD card.

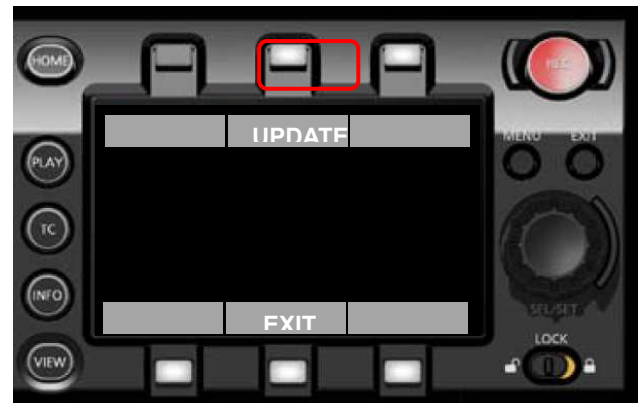
8. When "**UPDATE**" menu item appears, press the operation button of **UPDATE > OK**

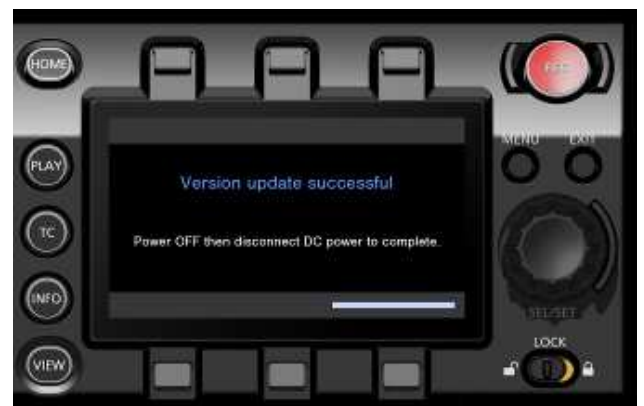
9. Wait until the "Version update successful" dialog is displayed. It may take **approximately 60 minutes (Maximum)**.

10. Remove the SD card.
11. Switch OFF the power, and disconnect and connect DC power > switch ON the power to complete.
12. Make sure the firmware version.

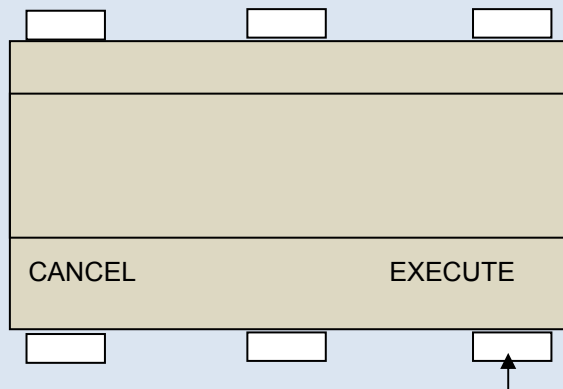
MENU: SYSTEM SETTINGS > COLOR SETTING
MAIN V-709
MENU: CAMERA SETTINGS > Enhanced > Enhanced SW > ON
MENU: CAMERA SETTINGS > BLACK > ABB

[EXECUTE] After about a minute, "ABB ACTIVE" is displayed on the panel.
When "ABB OK" is displayed, ABB is completed..

(1) ABB

The blemish compensation is performed. If the temperature of the sensor is between 42 and 44 degrees, the compensation effect is maximized.

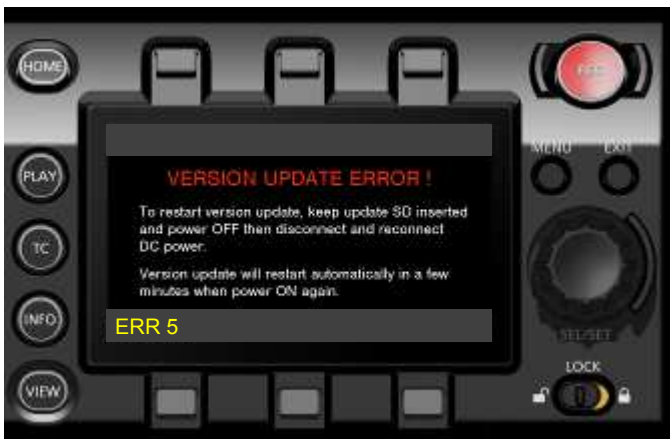
1. Update is failed with VERSION UPDATE ERROR! (ERR5)

Check points

- Is the folder name in the SD memory card surely "private"? Its folder name may often be renamed by computers automatically when downloaded and unzipped the package (example: renamed to private-2). In this case, rename it to "private" and try again.
- Is the directory of the firmware package correct as shown below?
